Technical Report

AN INFLATABLE CAUSEWAY

18 August 1964

U. S. NAVAL CIVIL ENGINEERING LABORATORY
Port Hueneme, California

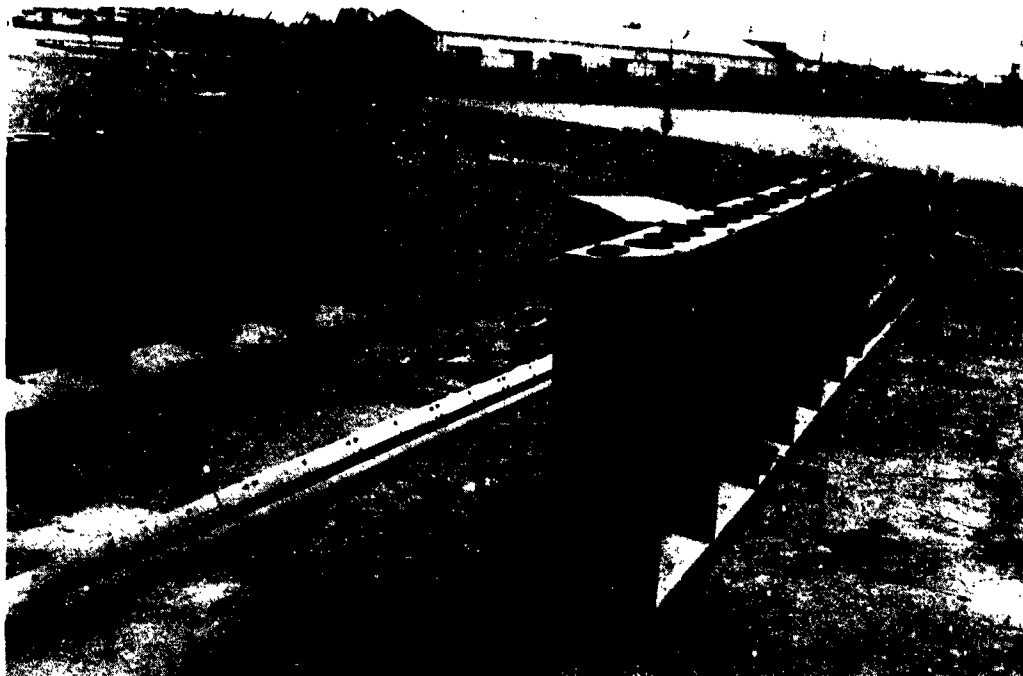
Figure 5. Assembling of modules into strings.

The method of assembling the superstructure is similar to that employed with the NL system. Alternate methods have been evaluated. Available handling equipment will normally dictate the method used. One method is to assemble all modules into longitudinal strings, transversely on end, as shown in Figure 5. Strings may then be combined, as shown in Figure 6. It may be noted in Figure 6 that the centerline deck tee member is connected to one string while the bilge tee member is connected to the other. This method will require hoisting equipment of at least a 22-ton capacity.

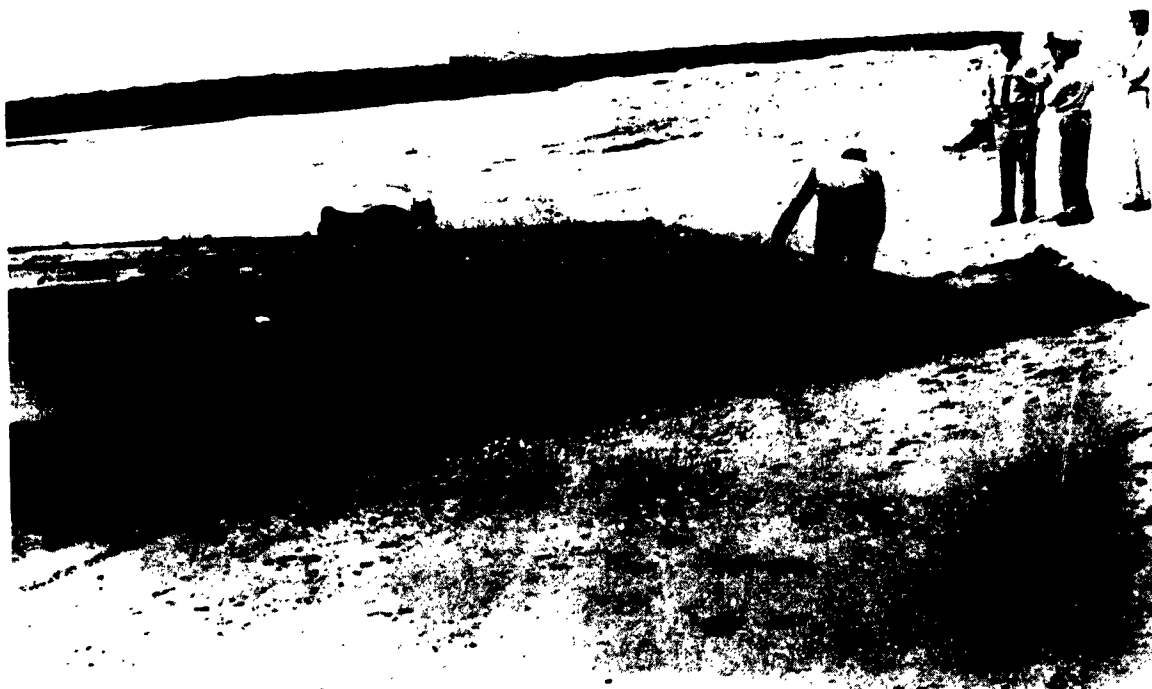
Figure 16. Beaching test with leading cells deflated.

The inflatable sections were successfully beached through surf ranging from zero to six feet on beaches with gradients ranging from 1:20 to 1:60. Nine beachings were made using NCEL-suggested techniques; i.e., deflating the lead cells of the beach section until the ramp just cleared the water. In the majority of the beachings, the causeway rode well up onto the beach, as shown in Figure 16; no transitional sand ramp was required. No cell failures due to beaching were reported. A ten-section causeway with inflatable units making up the first four sections is shown in Figure 17.

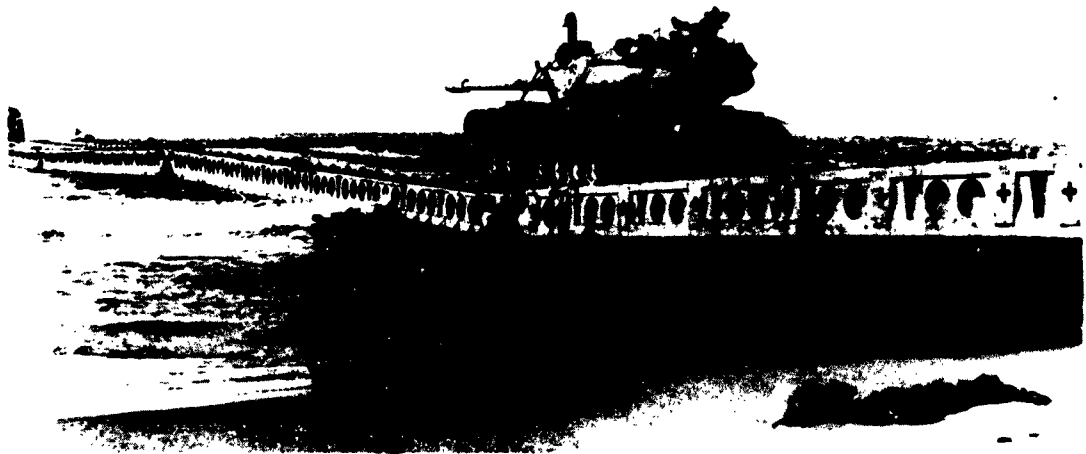
Figure 18. Sixty-two-ton tank traveling causeway.

The causeway provided an adequate roadway for all types of vehicles. During the evaluation period, a total of over 200 wheeled and tracked vehicles were driven on the causeway. The vehicles ranged in size from 1-1/2-ton jeeps to 62-ton M103 tanks. Note that the 62-ton tank in Figure 18 is fully supported, without benefit of flotation by the grounded cells. Stability of the inflatable sections during trafficability was good, and the vehicles negotiated on and off the beach ramp with comparative ease.
